TOWN OF WOLCOTT
Municipal Facilities Assessment

INTRODUCTION AND SCOPE

The purpose of this study is to assess the physical, including structural, condition and future feasibility of three building owned by the Town of Wolcott. This study will project facility needs over the next twenty years.

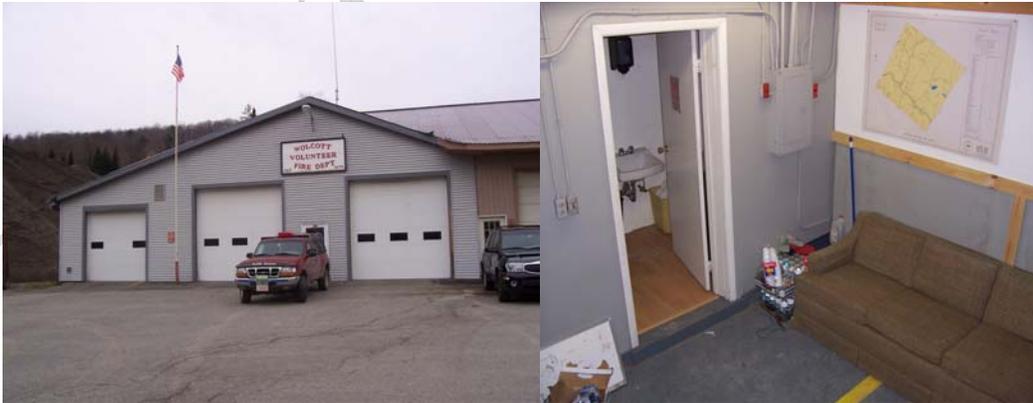
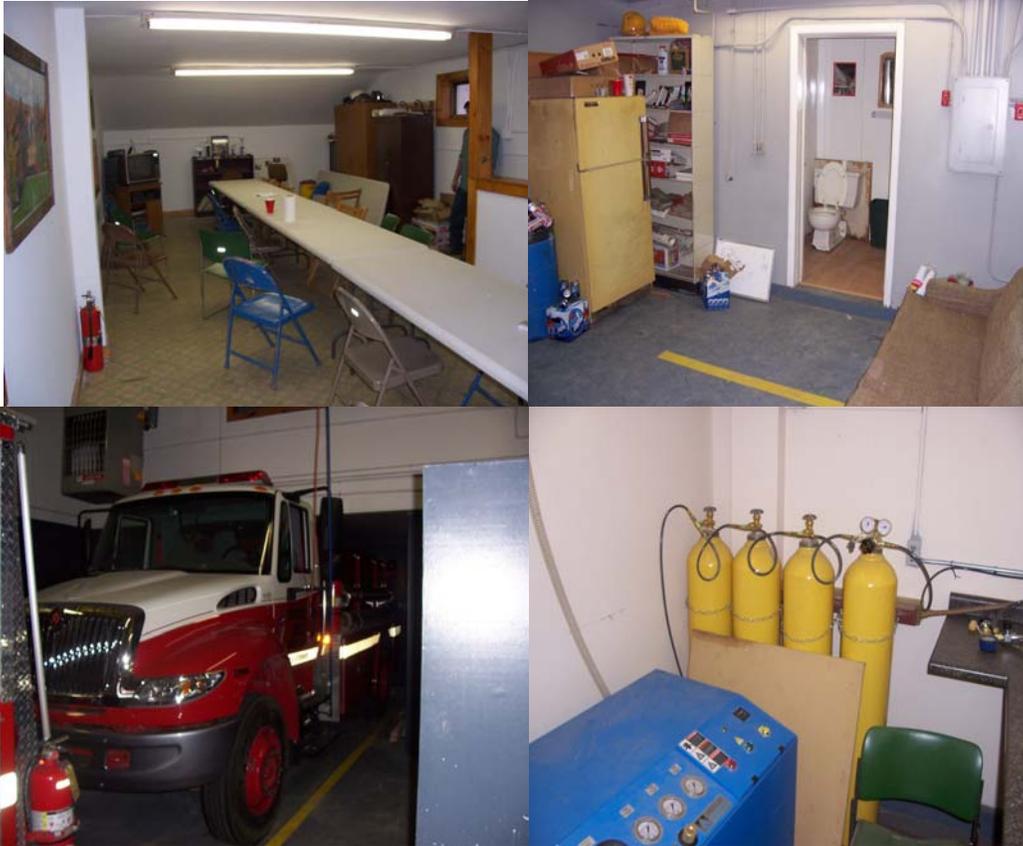
The current location consists of a 3,360 square foot building of wood frame construction. The original part of the building, according to town records, was built in 1975 with a later addition constructed in 1987. The structure houses the department's four trucks, firefighting equipment and gear, a small meeting/training room and support facilities.

- Electrical – Electrical system may be inadequate and is serviced by a 100 amp sub-panel from the main breaker panel in the Highway Department portion of the building
- Heating, Ventilation and Air Conditioning – Heating equipment is serviceable and adequate for the size of the building. The building is not serviced by a central air conditioning unit.
- Roofing and Siding – The vinyl siding and metal roofing are in reasonable condition. Regular maintenance is evident.
- Plumbing – Inadequate
- Structural/Foundation – No signs of deterioration of the slab foundation. Regular maintenance is evident.
- Mold – No obvious sign of mold present.

It is recommended that a new facility be considered within the next ten years to incorporate a larger more appropriate training room, off duty/break area and clean up facilities on a main floor configuration. With growth anticipated in out laying areas of the town it is recommended that a new location be identified and a new station be designed and constructed to meet the growing needs. Locations, especially any town owned parcels, along the Vermont Route 15 corridor should be given strong consideration

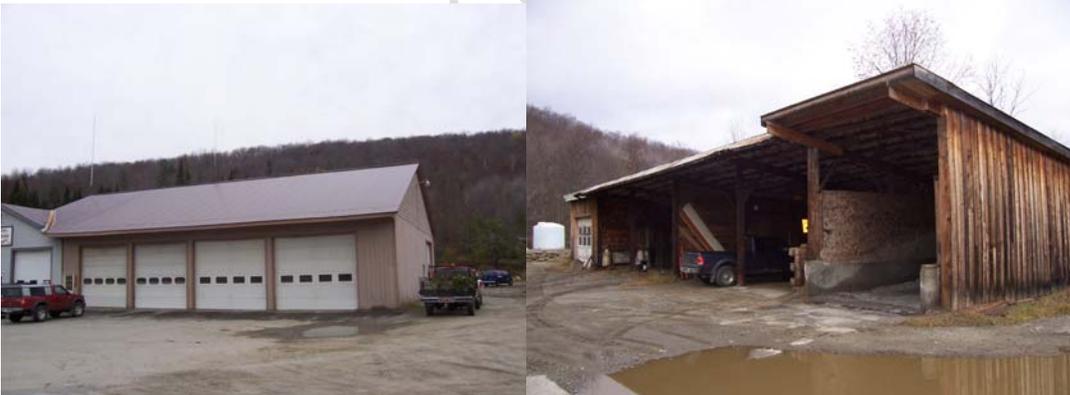
The existing highway garage was constructed in 1987 and is of wood frame construction with a concrete slab foundation. Its design and function is consistent with other facilities of its type throughout the area.

- Electrical – Appears adequate for the intended use of the building.

- Heating, Ventilation and Air Conditioning – Heating equipment is serviceable and adequate for the size of the building. The building is not serviced by a central air conditioning unit.
- Roofing and Siding – The wood siding and metal roofing are in reasonable condition. Regular maintenance is evident.
- Plumbing – Appears adequate for the intended use of the building.
- Structural/Foundation – No signs of deterioration of the slab foundation. Regular maintenance is evident.
- Mold – No obvious sign of mold present.

perhaps another highway department employee. The current facility could not support these additions without additional space. If the fire department relocates to a new more centrally located facility the Highway Department could expand into the existing Fire Department's space. Slight modifications could be required because of the expansion. The benefits of this scenario would allow a great deal of the existing equipment to be stored inside thus prolonging the unit's life.

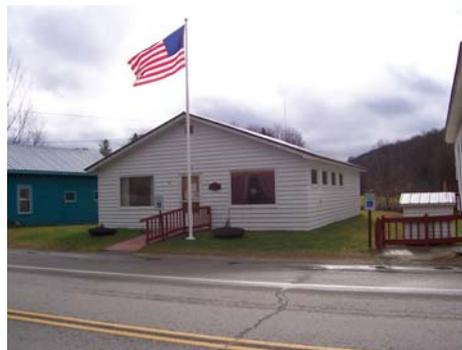
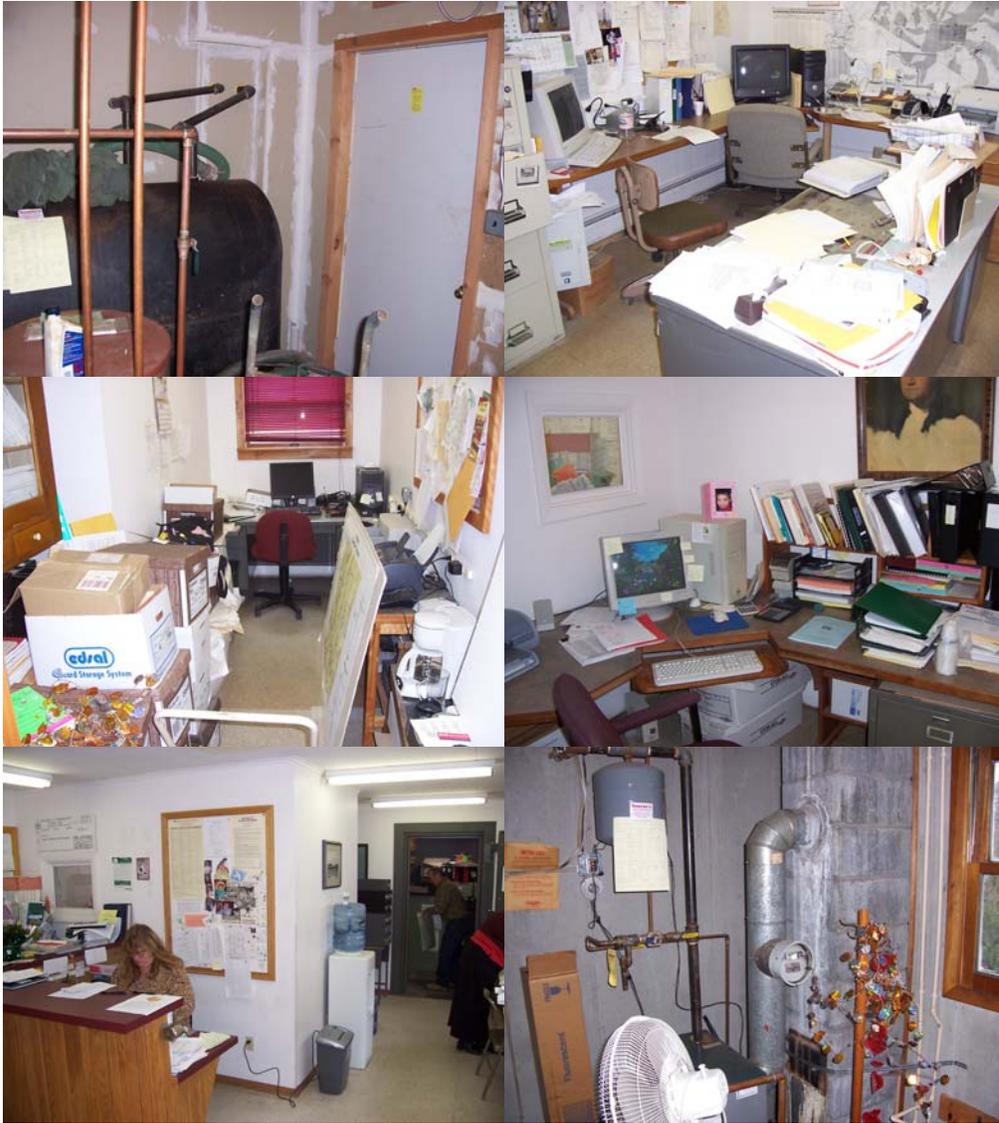
The entire building is now used for town offices including the Town Clerk, the Selectboard, Lister's office, Zoning, Heath Officer as well as other town related functions. The existing office space is crowded. Observing the workflow between all the necessary job functions is inefficient and cramped. The continued growth impact in community would make it difficult to even suggest a redesign within the current building. It has reached the maximum in its functional capabilities.

- Electrical – Electrical system may be inadequate due to increased use of modern office equipment (computers and copiers)

- Heating, Ventilation and Air Conditioning – Heating equipment is serviceable and adequate for the size of the building. The building is not serviced by a central air conditioning unit.
- Roofing and Siding – The wood siding and shingled roofing are in reasonable condition. Regular maintenance is evident.
- Plumbing – Inadequate
- Structural/Foundation – No signs of deterioration of the slab foundation. Regular maintenance is evident.
- Mold – No obvious sign of mold present.

As the needs of the town continue to grow it is recommended that the Town of Wolcott seek a new location for the municipal offices. The new location should be based on the space requirements detailed in the space calculation program. A new location should meet any existing code requirement at the time of construction and follow requirements set forth in the Department of Public Records Vault Kit program².

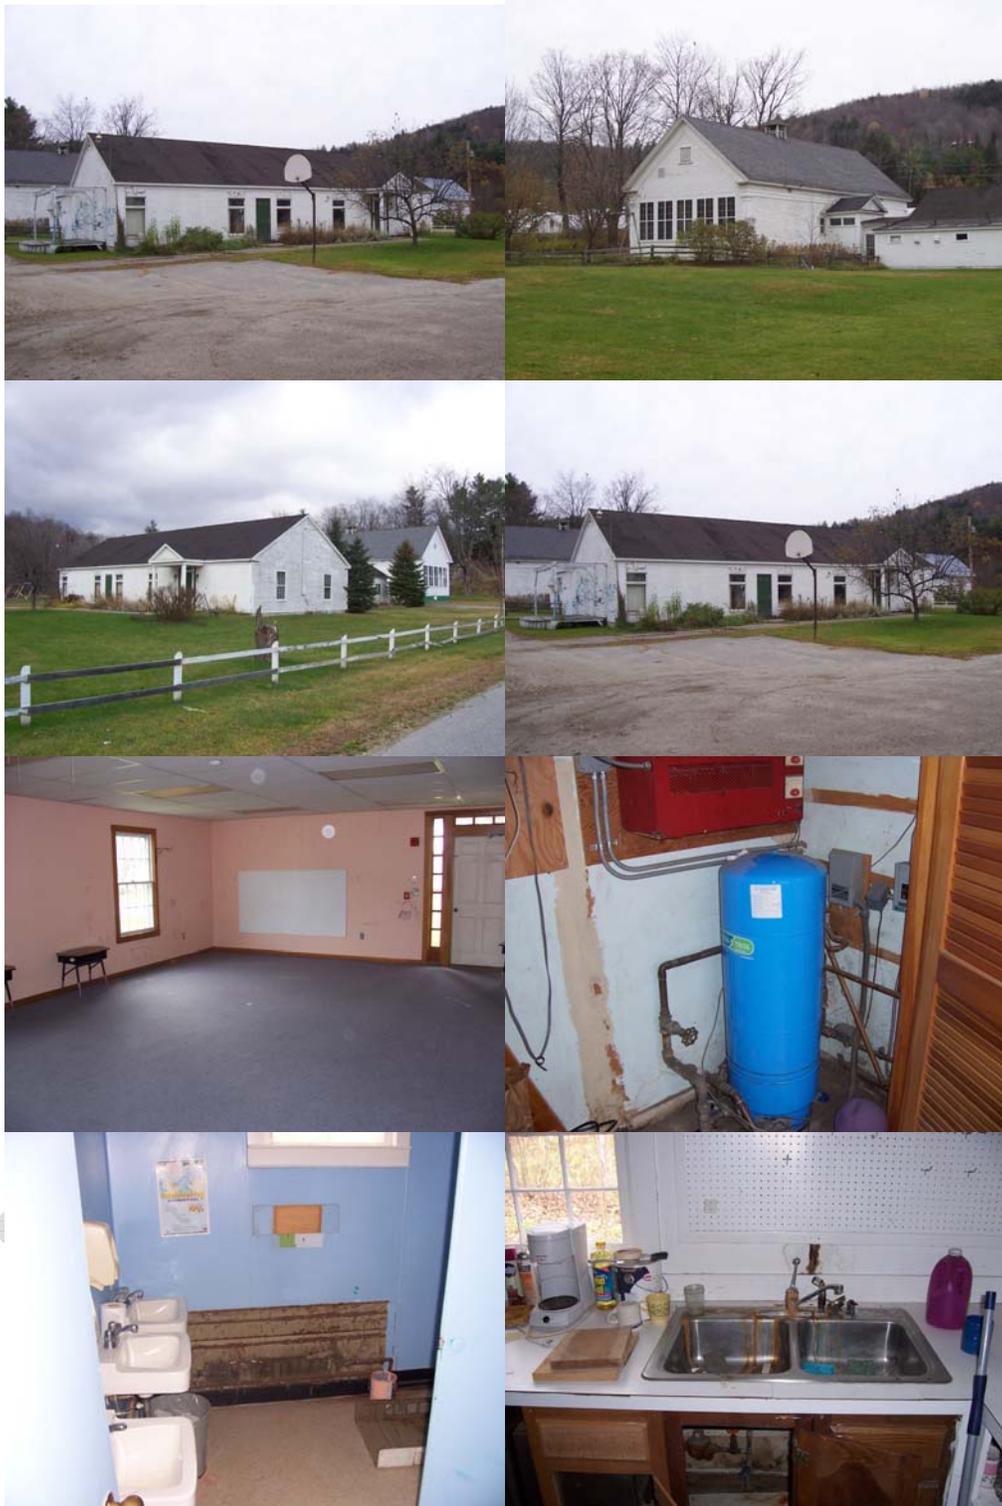
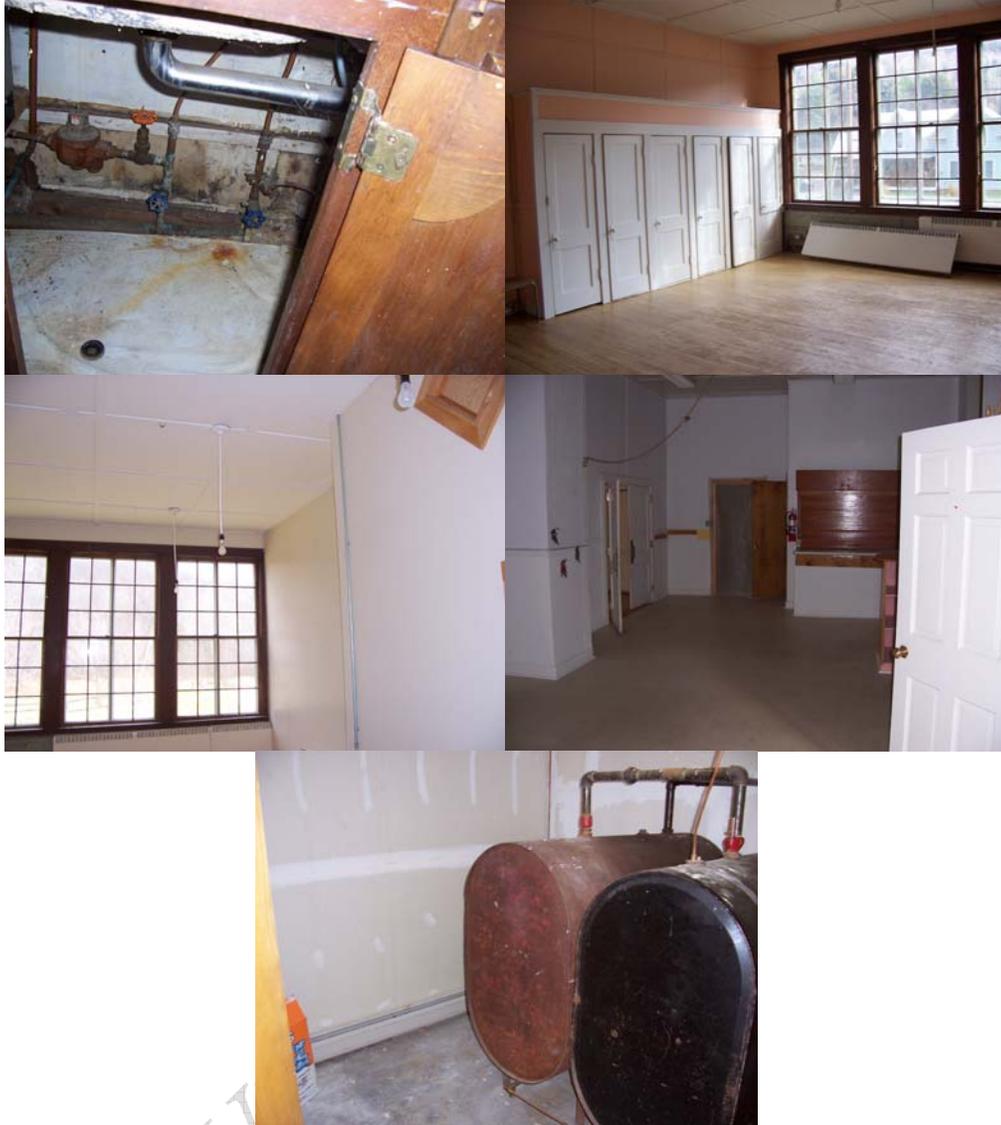
In the initial tour of the building by this consultant it appears that the building suffers from some deferred maintenance and a water leakage problem which may be the source of a musty odor, suggesting evidence of mold, throughout the building.

- Electrical - Adequate for the original intent and use of the building
- Heating, Ventilation and Air Conditioning – Adequate for the original intent and use of the building
- Roofing and Siding – Shows signs of deterioration
- Plumbing - Inadequate
- Structural/Foundation – Adequate for the original intent and use of the building.
- Mold – Evident – *further testing encouraged.*

In the context of future planning for the town this facility should be given strong consideration for re-use as municipal administrative offices. The overall square footage and footprint of the building allow for current and future needs of town offices to be adequate located here.

It should be noted that although the square footage of the building is more than adequate, to house the town offices for example, its current configuration would need to be modified, unnecessary structures demolished, historic parts of the structure preserved and the defects noted in this report be addressed and corrected. Our research indicates that environmental testing specific to mold has been performed at the site several times during 2005 and reports have been presented. It is unclear if a remediation plan has been developed.

In the absence of a remediation plan further investigation by an industrial hygienist qualified may be required to perform additional testing or to develop a remediation plan for the site. Professionals to whom we have consulted indicate that an evaluation of this type could the cost area of \$1,500 - \$2,000 for initial site visits, applicable lab testing and a detailed report³.
